YOUR Inspection Report

186 East's Corners Boulevard
Vaughan, ON L4H 3N5

Sunday, April 14, 2024

Report No. 8152

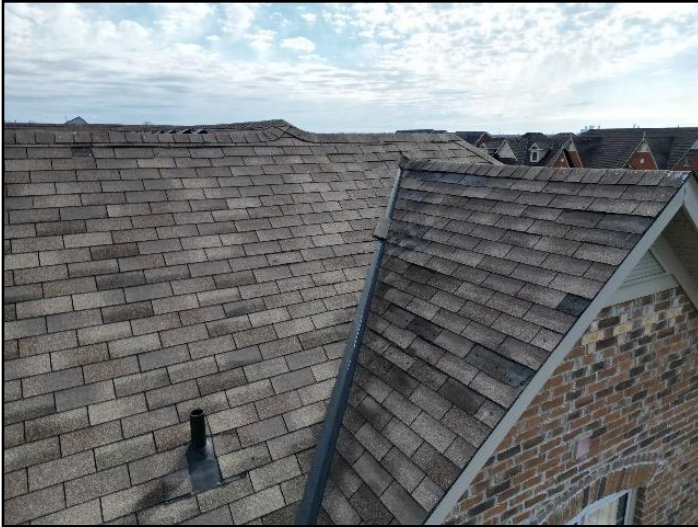
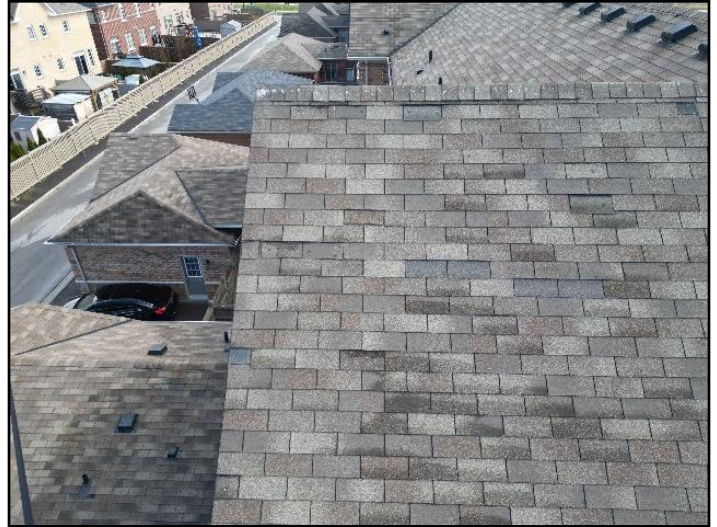
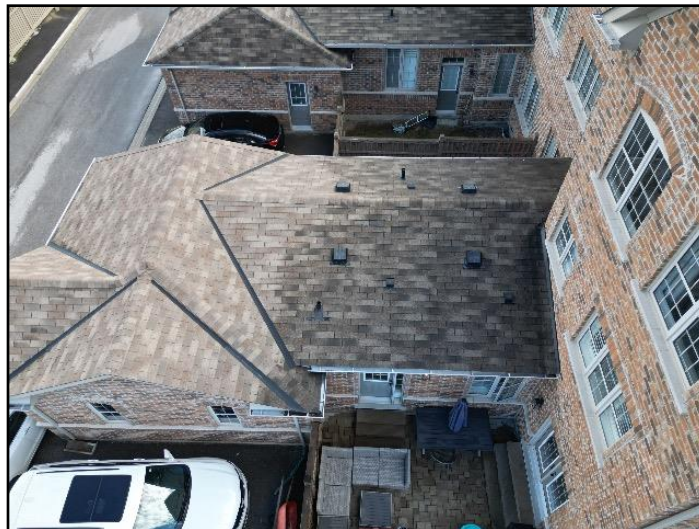
Condition: • View of roof from above:

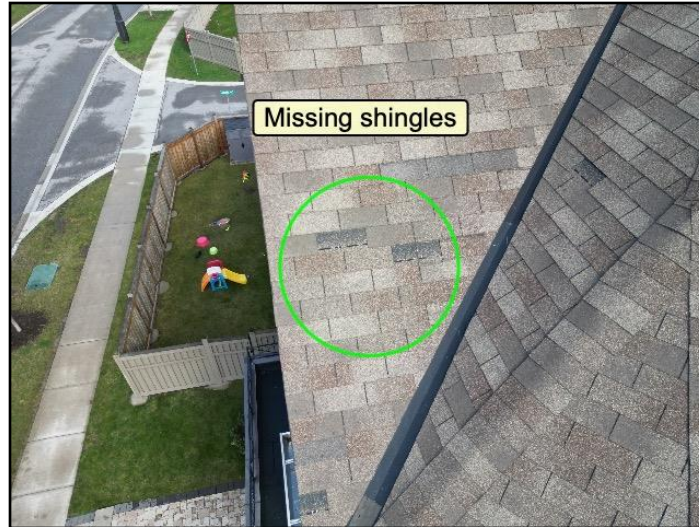
SLOPED ROOF(S) \ 1.0

Condition: • Missing

Task: Repair

Time: As soon as practical

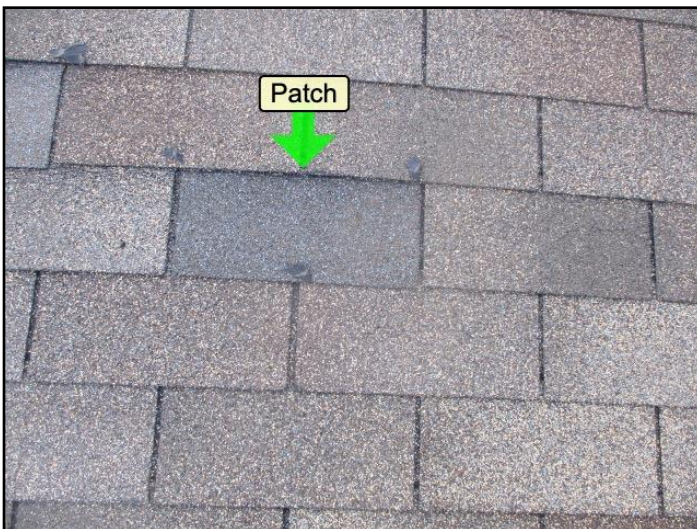
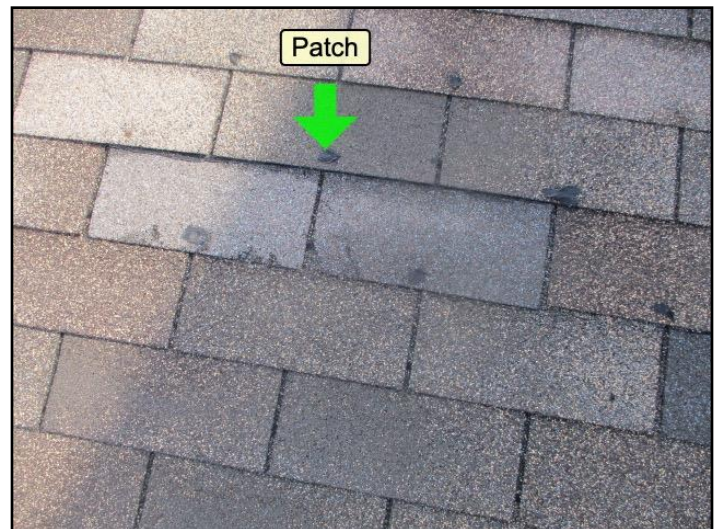
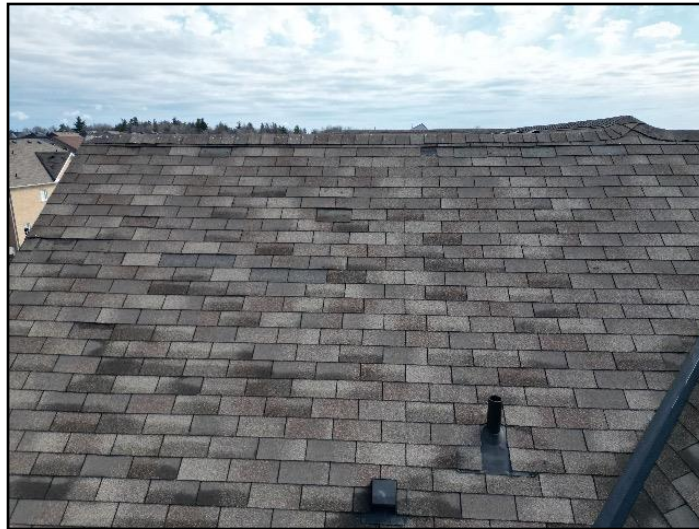
Condition: • Patched

Task: Ask homeowner for insight

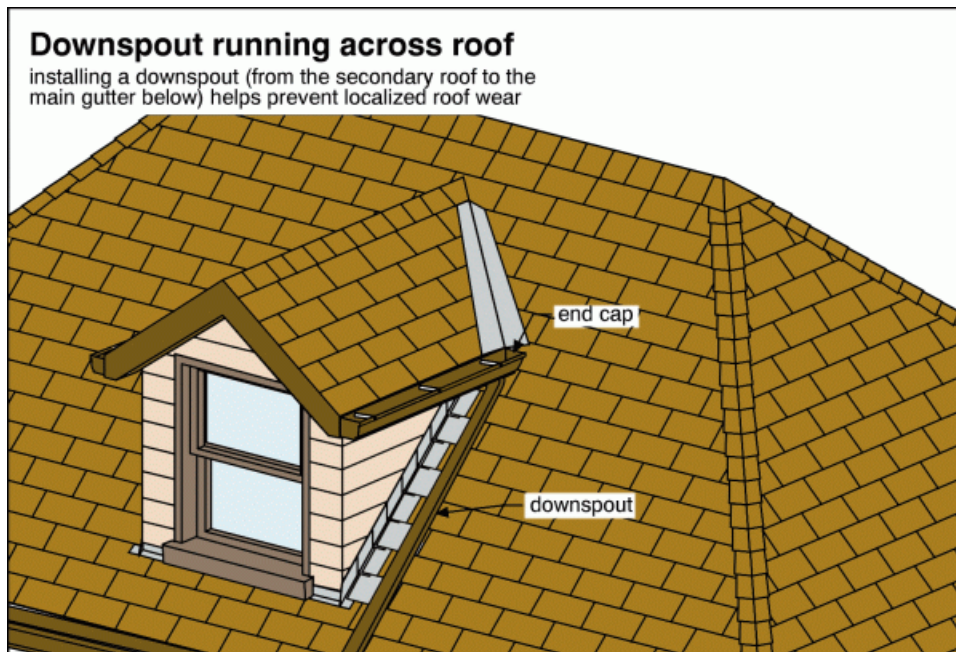
DOWNSPOUTS \ 1.0

Condition: • [Discharges onto roof - extend to lower gutter to protect lower roof](#)

Task: Repair

Time: Less than 1 year

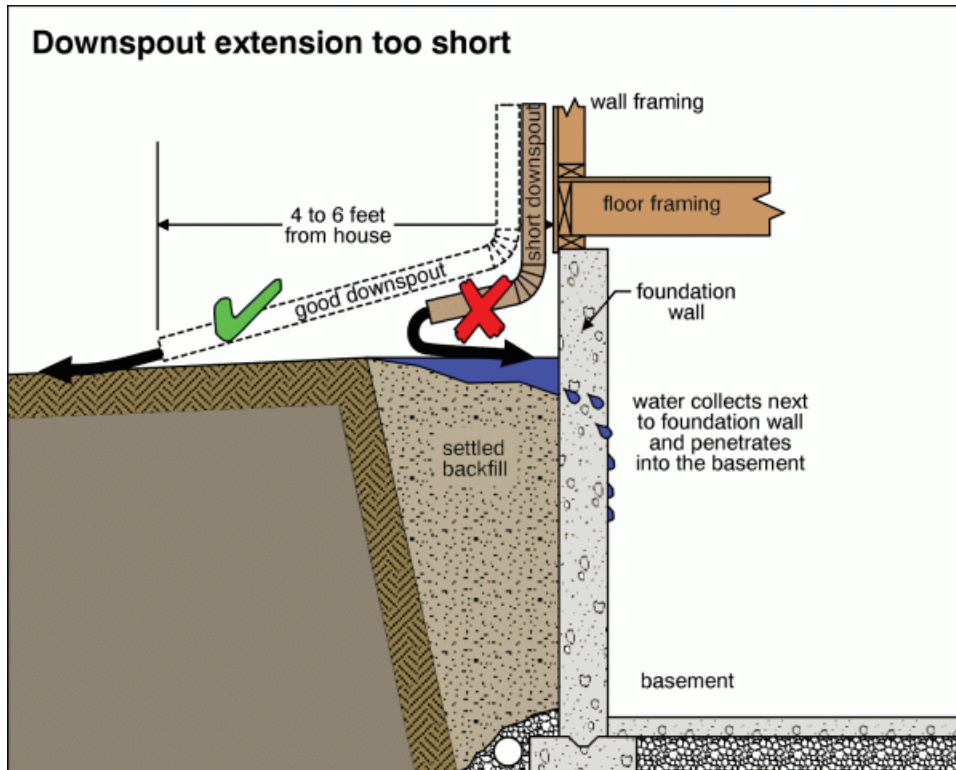
Location: Throughout Exterior

Condition: • [Downspout ends too close to home. It should direct water at least 6 feet from building.](#)

Task: Correct

Time: Less than 1 year

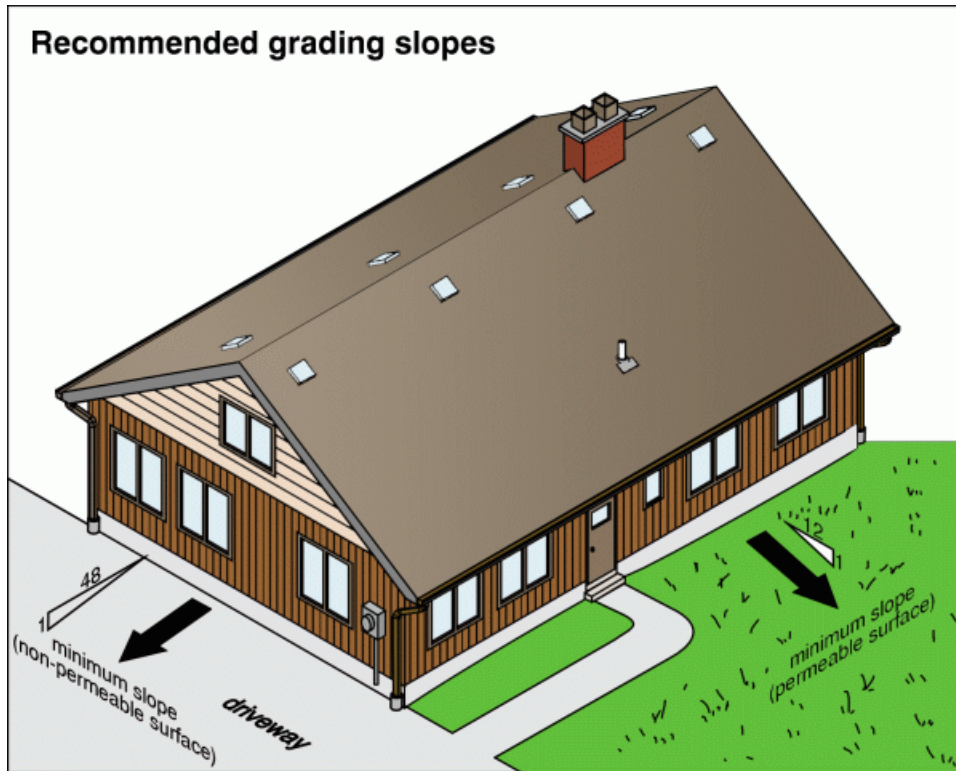
LOT GRADING \ (2.0 & 6.0)

Condition: • Low areas

To reduce the likelihood of water penetration to the basement, always maintain a positive slope away from the foundation wall.

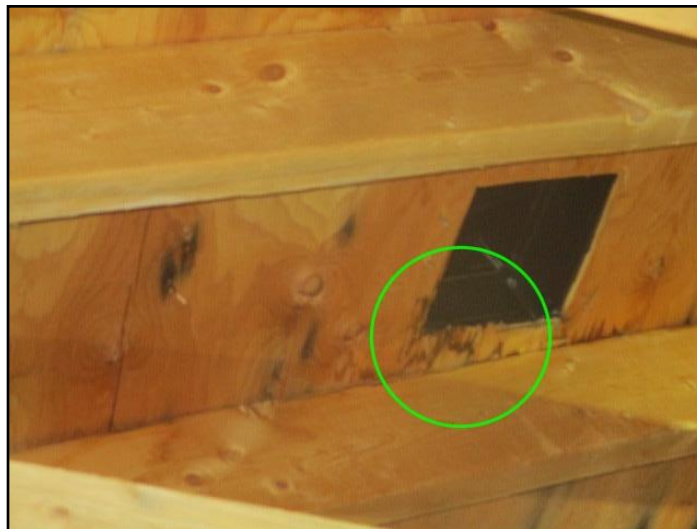
Location: Attic

Condition: • [Water stains](#)

Task: Monitor over time

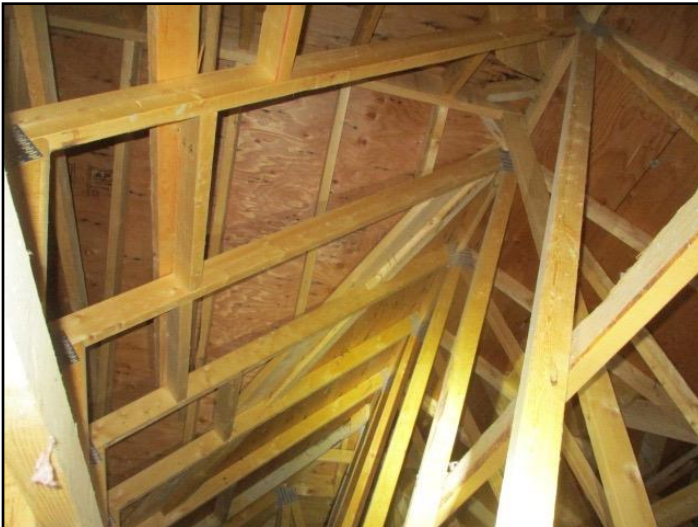
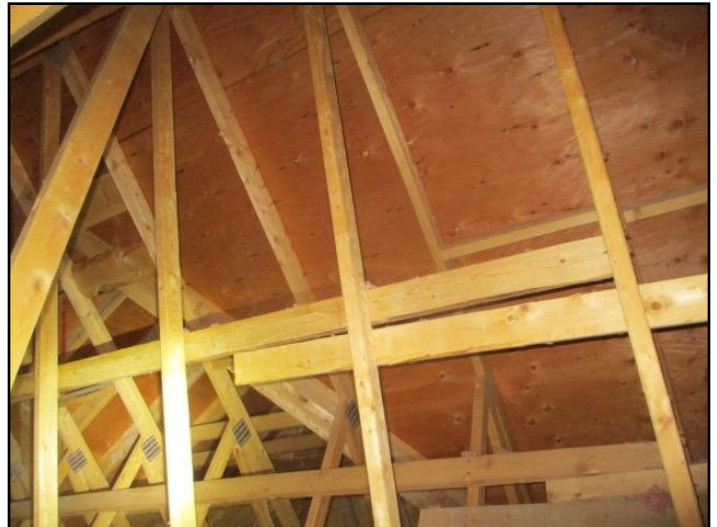
Condition: • View of attic:

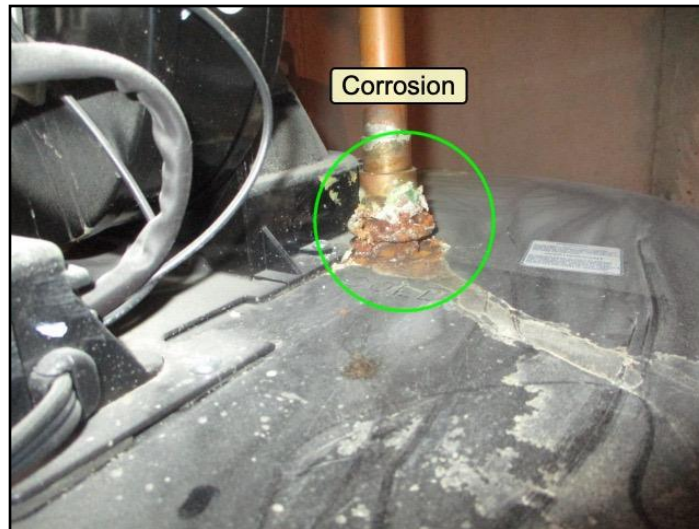
WATER HEATER \ 1.6

Condition: • [Rust](#)

Task: Repair or replace

Time: As soon as practical
